ACCRS
HO Monthly Meeting
Minutes
November 3, 2017

ACCRS HO Scale Electrical Improvement Group

Evaluation and Identification of HO Scale Lay Out Electrical Issues

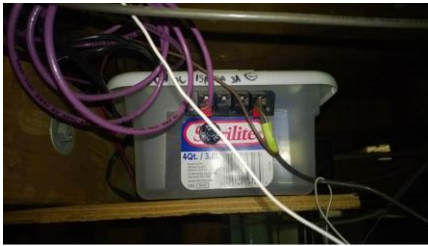
- a. Building lighting, Miller engineering animated signs, Street lights, Crossing/Signals lighting, special effect lighting. Currently 12v and 5v DC voltages are used. In the city area plastic boxes have been used to enclose computer power supplies. These supply 12 v DC to power lighting and accessories in the city area. Periodically these supplies blow fuses. This indicates that they are not rated correctly for the current draw placed on them. The use of the used equipment is suspect with respect to design and operation. There is no inventory of what is used and what the power requirements are.

3. Create logical zones in the layout for feature/accessory wiring and provide structured wiring.
4. Purchase quality power supplies, distribution blocks and for feature/accessory wiring.
5. Use electrical contractors when needed for 110v - 120v wiring.
6. Implement a change control policy for all electrical work.
7. Update existing electrical and wiring documentation.
8. Leverage Wiki software tools to enable collaboration with web based access.
9. Purchase spares for NCE DCC system. Currently being considered.

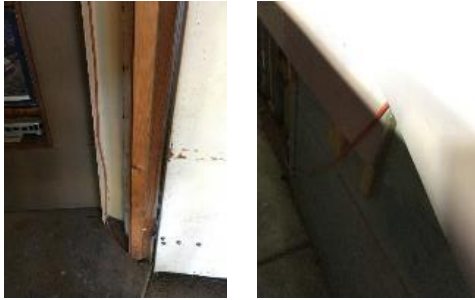
- d. 110v - 120v usage will not pass inspection (extension cords). Extension cords have been used rather than provide conduit and receptacles to provide power to TV monitors and the exterior wig wag signal. This practice is illegal.

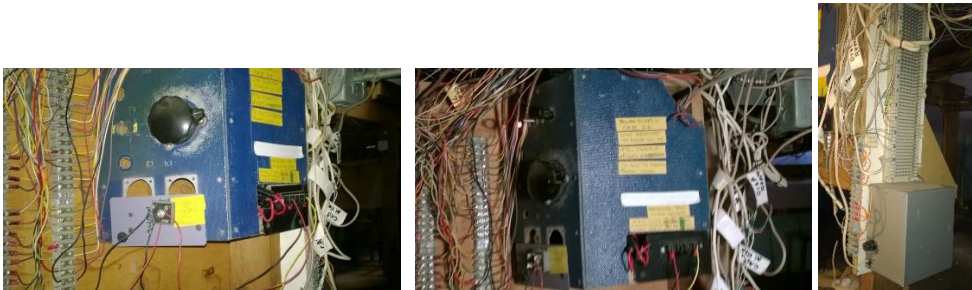
- e. Cab 3 Wiring DC Power Supply. It unclear how this system is installed and what various components are used for. This supply needs to be examined and upgraded.
